**VOLUNTARY CLEANUP COMPLETION REPORT  
FOR  
COLUMBIA AND OLD PRO PATRIA MILL TAILINGS,  
AND SILVER SWAN MINE EAST WASTEROCK PILE  
RICO, COLORADO**

**ARCO Environmental Remediation L.L.C.**  
307 E. Park Street, Suite 400  
Anaconda, Montana 59711

**ESA Consultants Inc.**  
2637 Midpoint Drive, Suite F  
Fort Collins, Colorado 80525

September 17, 1999

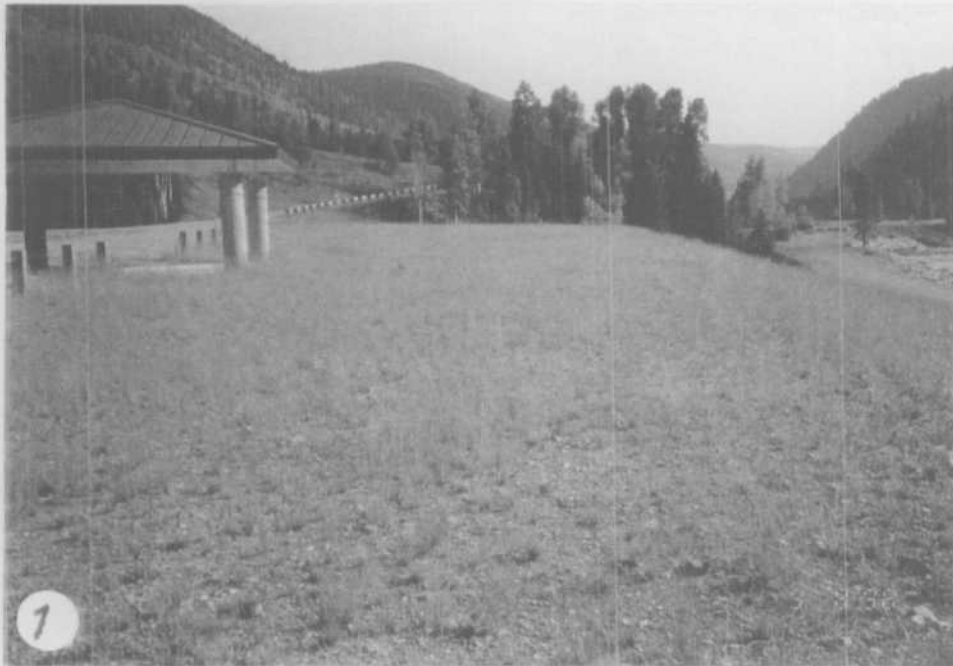
Photo #	Description
1	Near northern facility border looking south-level upper surface.
2	Near northern facility border looking south-level upper surface and eastern facility outslope.
